INSPECTION  
REPORT

Inspection Performed at  
**3015 Mission Beach Rd Tulalip Bay,  
Washington 98271**

**Subject:** This Report is Intended for a Thorough Demolition Good Faith Survey

This report presents our findings from an asbestos survey completed on 10/14/2023 for the building currently utilized as an Commercial Space at 3015 Mission Beach Rd .

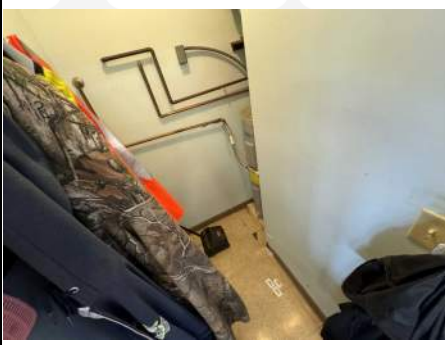
Samples: LCB01-A  
 Description: Covebase / Adhesive / Joint Compound  
 Note: Light Brown

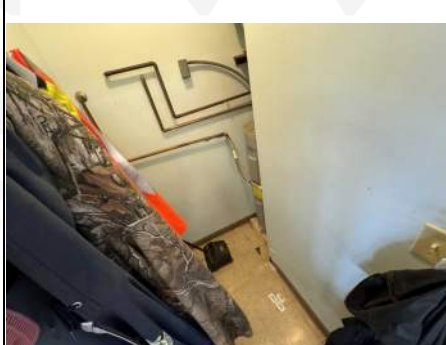
Samples: LD01-A  
 Description: Paint / Joint Compound / Drywall  
 Note:

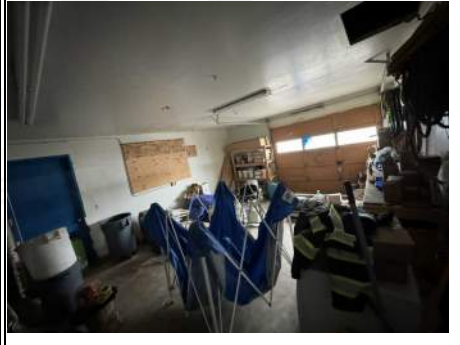
Samples: LF01-A  
 Description: Mortar / Joint Compound  
 Note: Concrete poured foundation

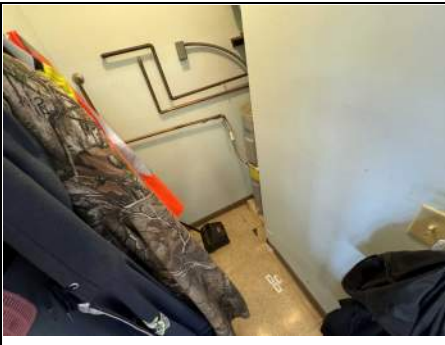
Samples: LFL01-A  
 Description: FT1 - Floor Tile 12x12  
 Note: Floor tile w/ adhesive

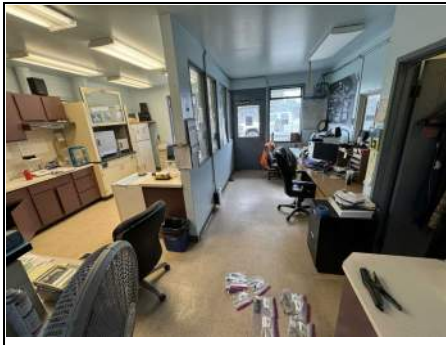
Samples: LFL01-B  
 Description: FT1 - Floor Tile 12x12  
 Note: Floor tile w/ adhesive
