Subject: Report of Geotechnical Investigation and Engineering

MTC Project No.: **22B116**

GEOTECHNICAL INVESTIGATION AND ENGINEERING REPORT

Proposed Tulalip Utilities Building Site Development
Snohomish County Tax Parcel Numbers 00616500600100 & 00616500600200
3015 Mission Beach Road, Tulalip, Washington

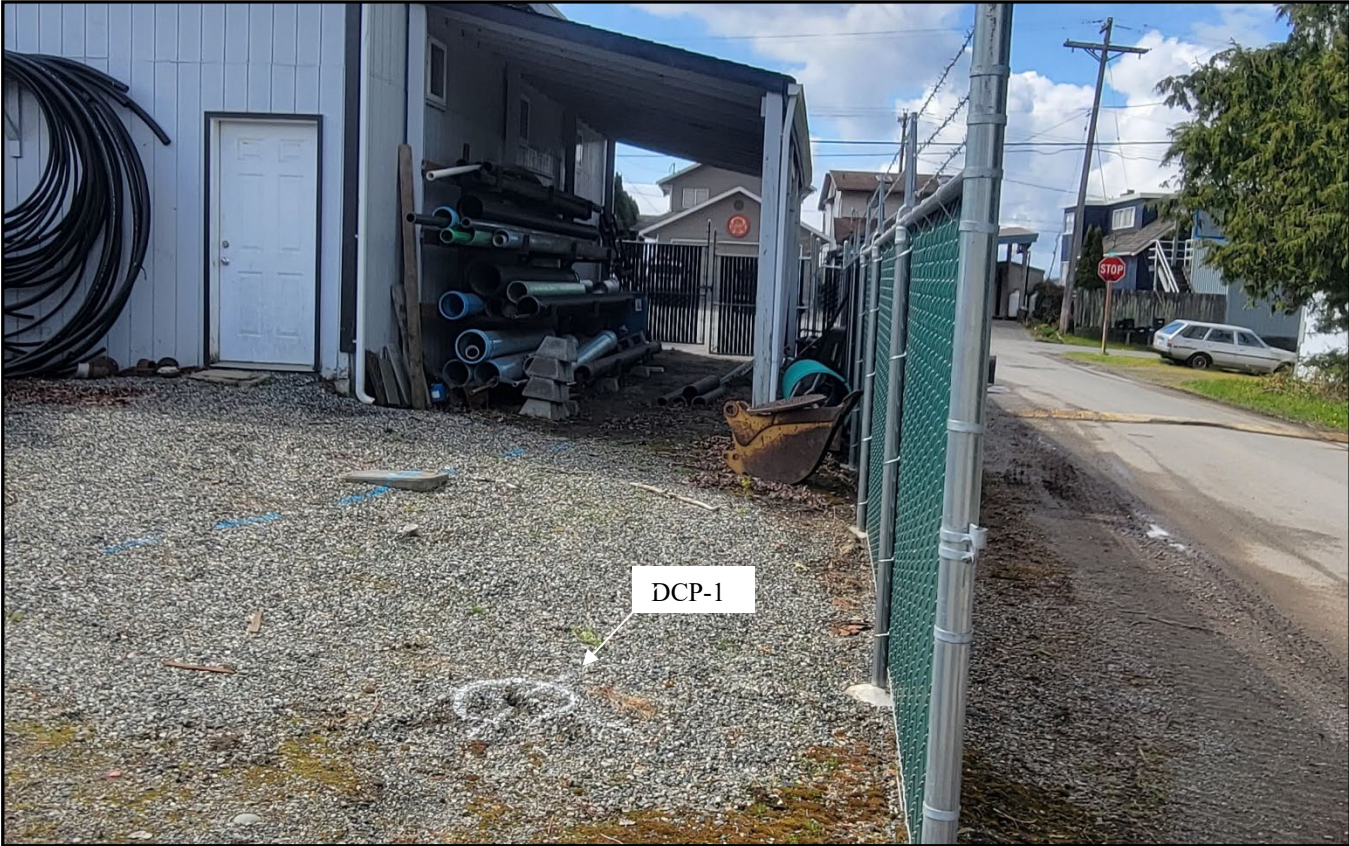
Photo A: Looking south at the northwest corner of the building. DCP-1 in progress

DCP test results confirmed consistencies of the soils observed via test pits and were used to assess soil densities at depths beyond test pit termination. At all DCP test locations, except DCP-2, surface soils in the upper 2.7 feet ranged from very loose or loose to medium dense. The soil conditions below 3.1 feet BPG become consistently medium dense to dense. DCP tests were terminated due to refusal between 8.8 to 13.5 feet BPG in dense soils.

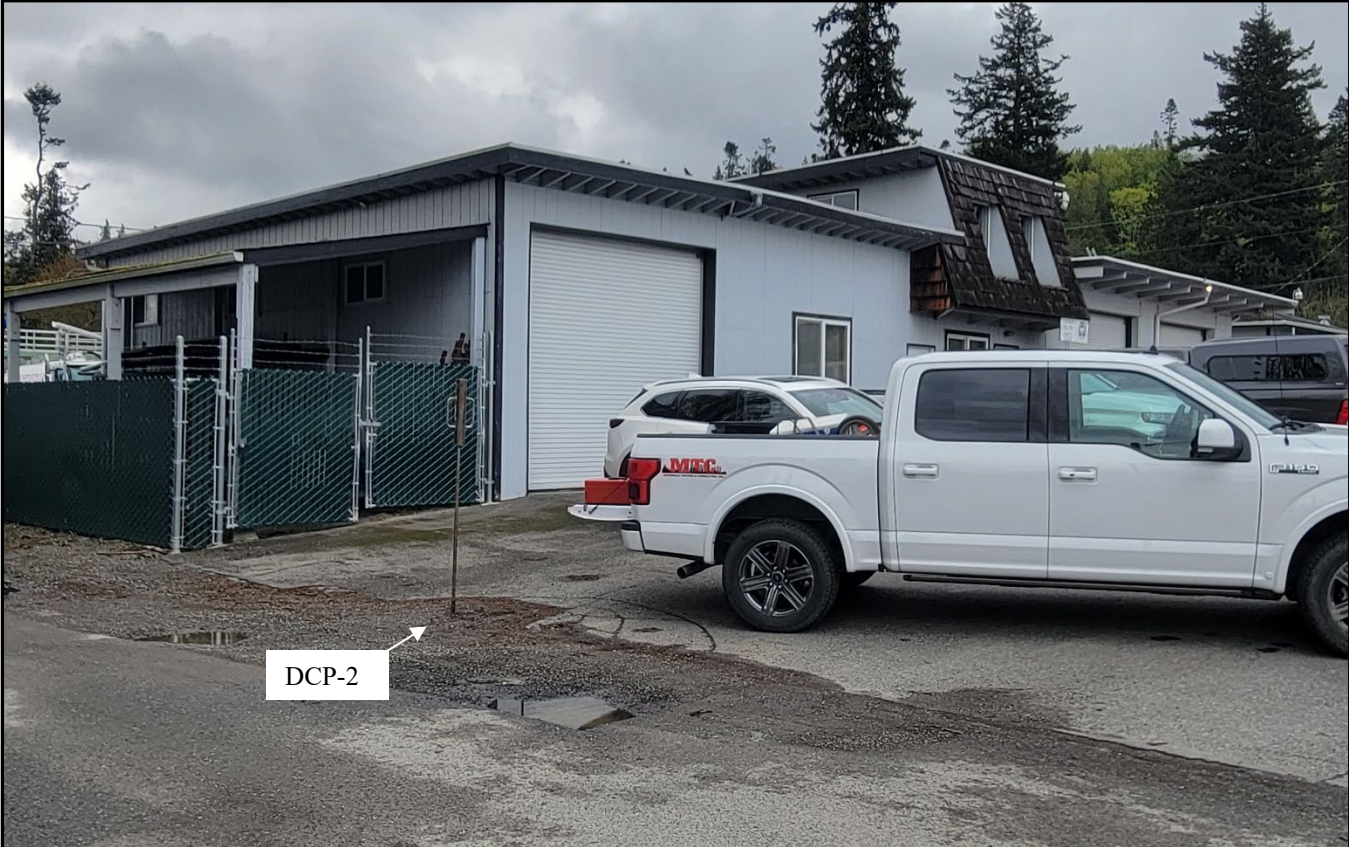
Photo B: Standing on 30th Drive NW, looking northeast at the existing building. DCP-2 in progress.

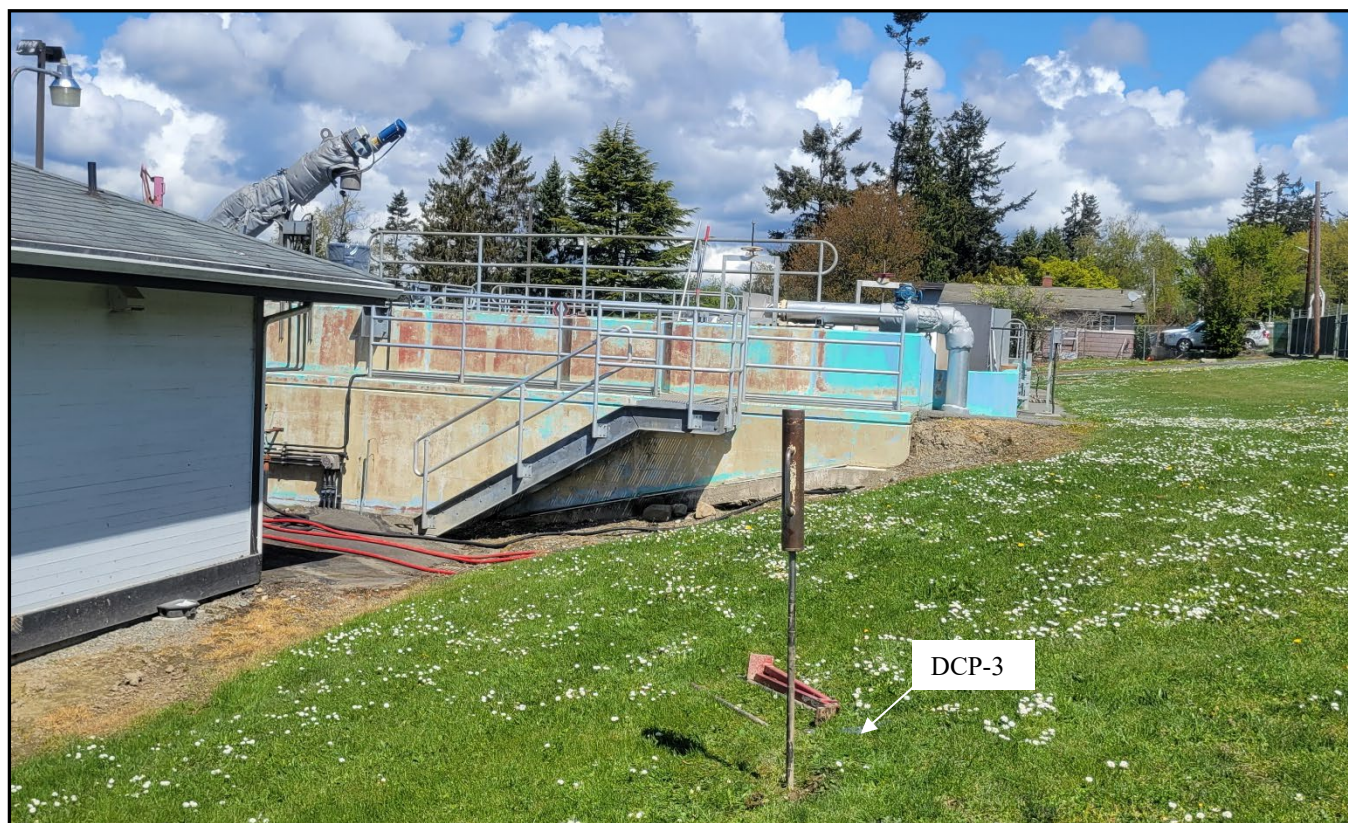
Photo C: Looking north DCP-3 in progress.

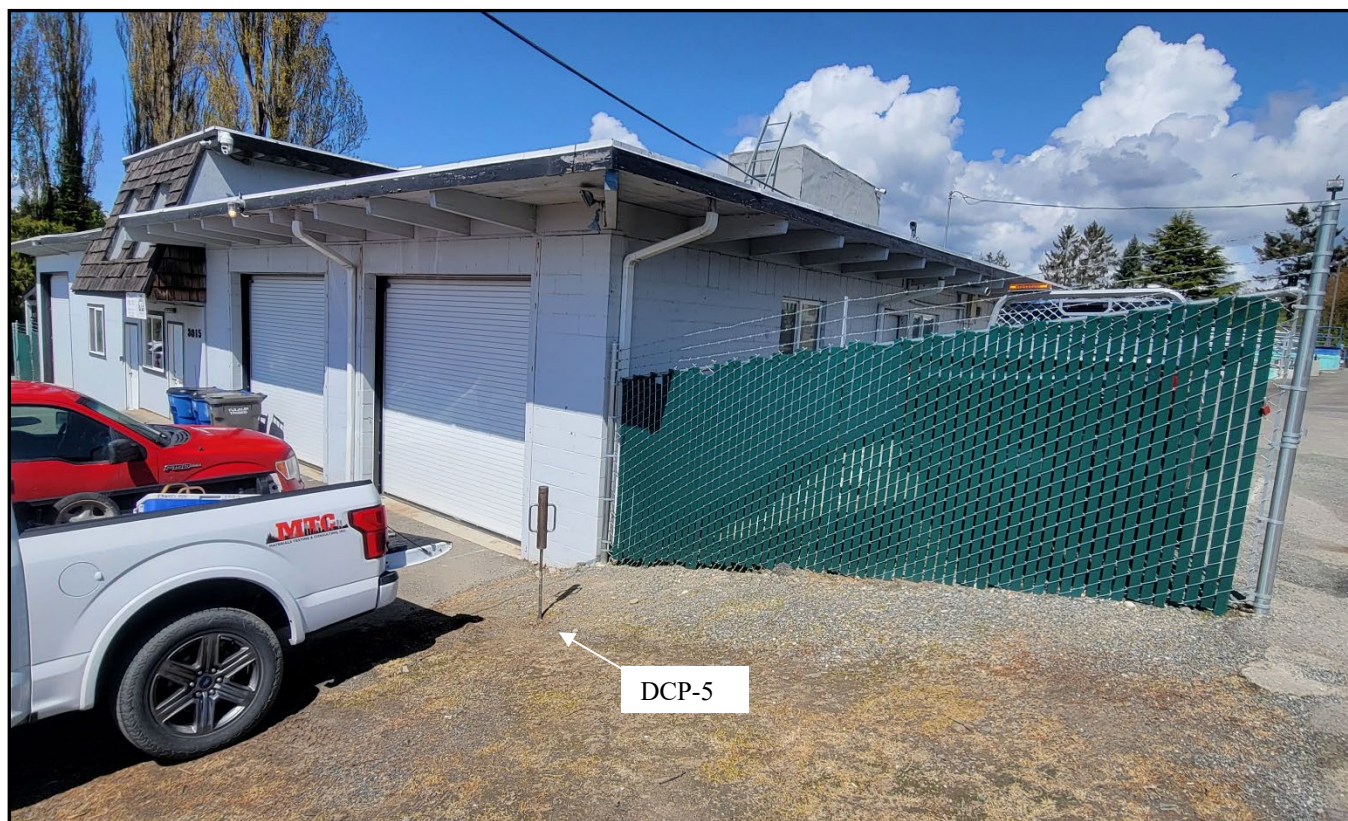
Photo D: Looking north at the southeast corner of the building. DCP-5 in progress.

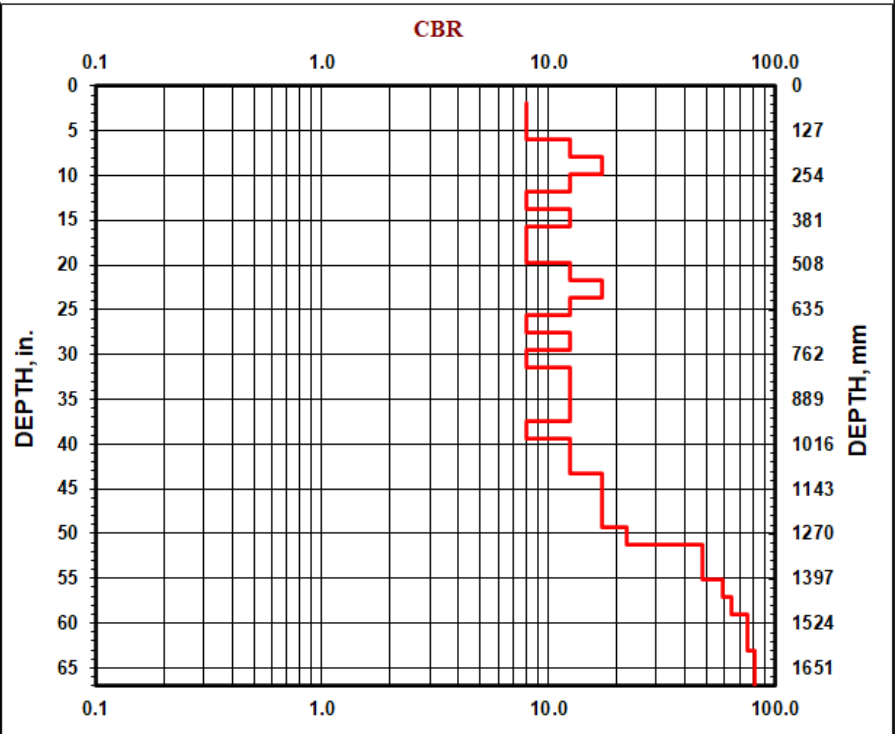
WILDCAT DYNAMIC CONE LOG

No. of Blows	Accumulative Penetration (mm)	Type of Hammer
1	50	1
2	100	1
2	150	1
3	200	1
4	250	1
3	300	1
2	350	1
3	400	1
2	450	1
2	500	1
3	550	1
4	600	1
3	650	1
2	700	1
3	750	1
2	800	1
3	850	1
3	900	1
3	950	1
2	1000	1
3	1050	1
3	1100	1
4	1150	1
4	1200	1
4	1250	1
5	1300	1
10	1350	1
10	1400	1
12	1450	1
13	1500	1
15	1550	1
15	1600	1
16	1650	1
16	1700	1

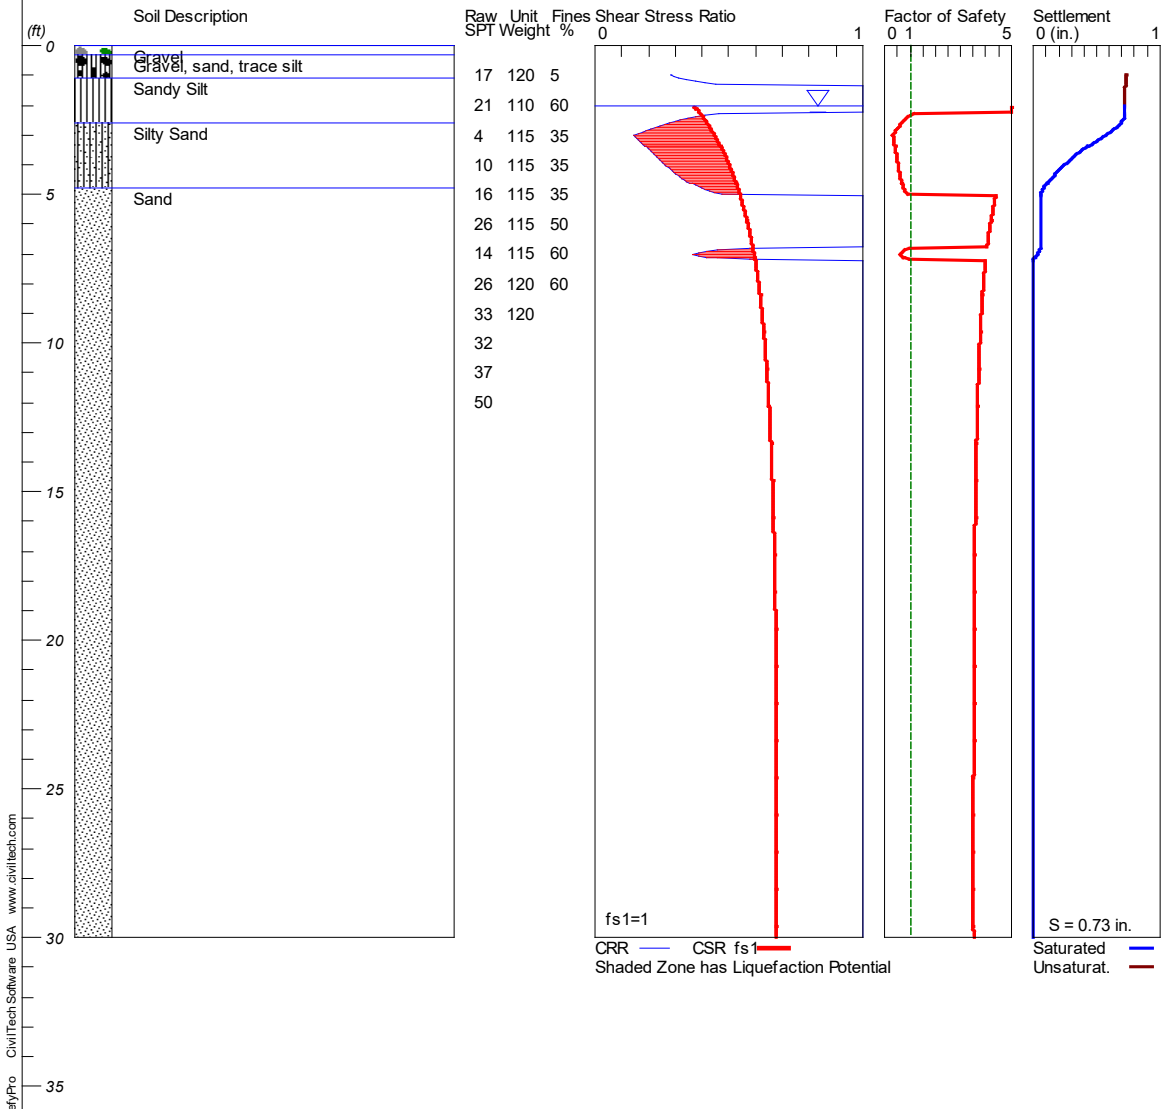
Tulalip Utilities Building - Sample Location #1

Hole No.=5 Water Depth=2 ft Surface Elev.=35

Magnitude=7
 Acceleration=0.574g

Analysis was completed using LiquefyPro, Version 5.8h, published by CivilTech Software©. LiquefyPro performs liquefaction settlement analysis in accordance with the latest National Center for Earthquake Engineering Research (NCEER) Workshop recommended procedures and provides several options for the treatment of data inputs. Settlement estimates were obtained utilizing methods of Tokimatsu & Seed (1987) and Ishihara & Yoshimine (1990). A 7.0 magnitude earthquake event was applied. Calculations were completed for maximum considered earthquake peak ground acceleration (0.574g) as provided by the ASCE 7-16 guidelines. To reflect liquefaction risk of existing conditions most accurately, no factor of safety or external surface load was applied. For purposes of assessing a conservative scenario of liquefaction potential, the predominantly fine-grained members of the stratigraphy were not prohibited from liquefaction. Table 2 summarizes the results of MTC’s liquefaction analysis represented graphically in Appendix E.

Liquefaction analysis predicts a maximum potential seismic-induced ground settlement ranging from 0.60 to 1.05 inches, representing existing conditions with no ground improvements or surcharge loading from building pad preparations and under maximum considered earthquake peak ground acceleration and seasonally elevated groundwater tables. This analysis is based on liquefaction-induced settlement in the upper 13 feet of the profile where DCP tests terminated in dense conditions. Actual total accumulated settlements may be higher when fully considering the upper 50 feet of the subsurface profile. However, in our opinion the generally suitable conditions at end depths do not warrant further investigation and
